### Canon 814XL "fps" dial repair.

The 814XL that was in the underwater blimp had a faulty dial for the frame rate. No matter where you turn it, it's still frame rate. The lens and finder are beautiful, and it even has a focus gear for the blimp. I must fix this.

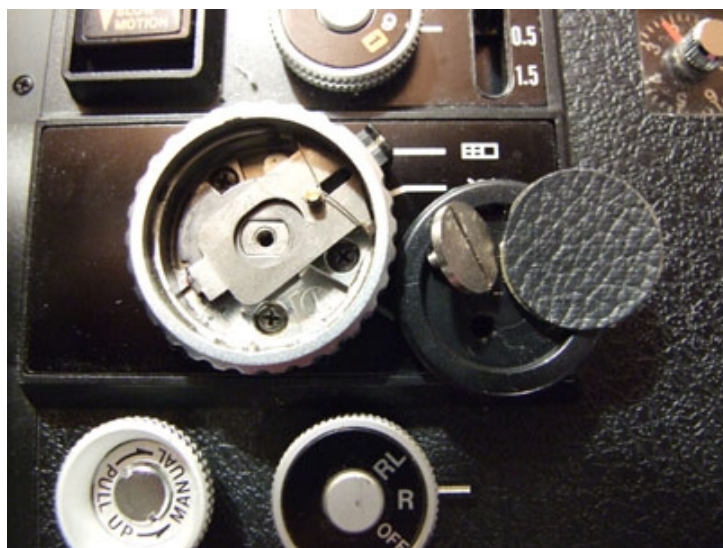
814XL that existed in an underwater housing was out of order. It is possible only to single frame. The lens and the finder are beautiful, and the focus gear has adhered. I must repair by all means necessary.

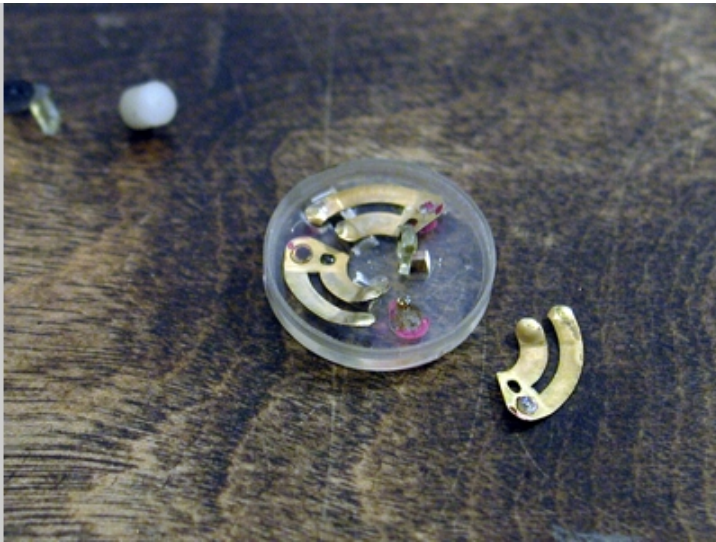
This dial on the later Canon cameras, the plastic rivets on the terminals often break due to aging.

The later Nizo also uses a similar part. It is more taxing because it is on both sides of the board.

This part of the Canon camera has the problem. It is breakable.

Parts that Nizo is similar are used. It is more taxing because Nizo is in both sides.

This is really delicate made, and bad .

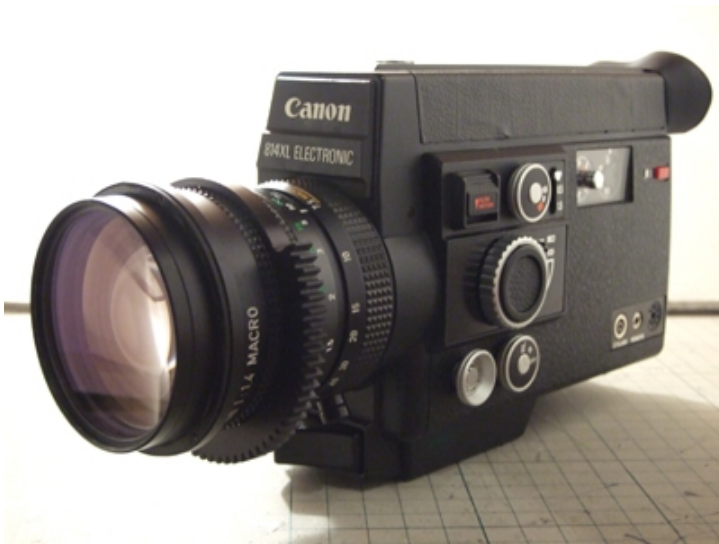
It was perfect. Thank goodness.

All are good. Good!
